Contract #: 04-0120F4Cty: SF/ALA Rte: 80 PM: 13.2/13.9File #: 69.28**WELDING INSPECTION REPORT****Resident Engineer:**Pursell, Gary**Address:** 333 Burma Road**City:** Oakland, CA 94607**Report No:** WIR-003869**Date Inspected:** 04-Sep-2008**Project Name:** SAS Superstructure**OSM Arrival Time:** 1430**Prime Contractor:** American Bridge/Fluor Enterprises, a JV**OSM Departure Time:** 2000**Contractor:** Zhenhua Port Machinery Company, Ltd (ZPMC), Changxing Island **Location:** Shanghai, China

Bridge No: 34-0006**Component:** OBG Floor Beam**Summary of Items Observed:**

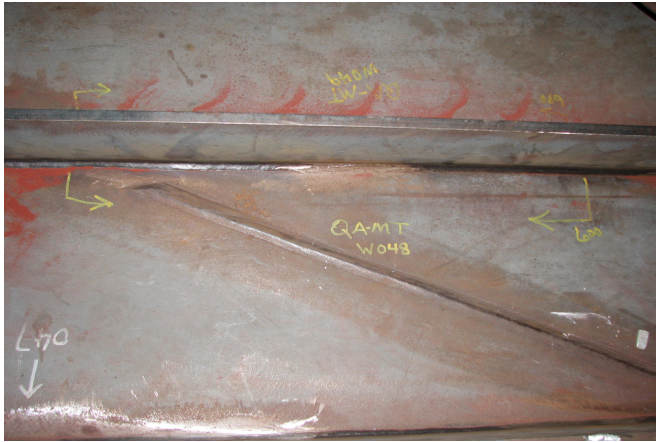
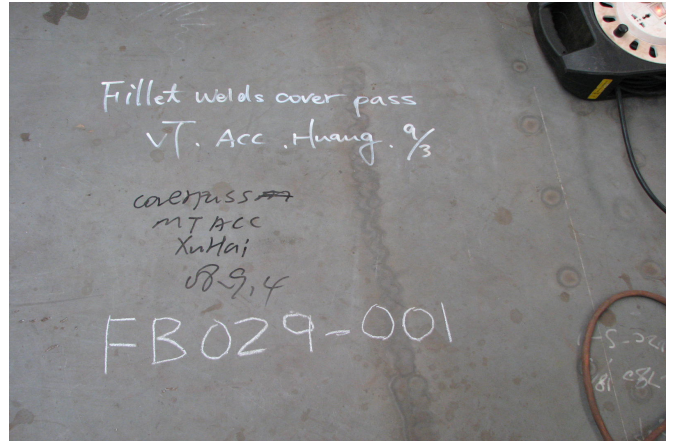
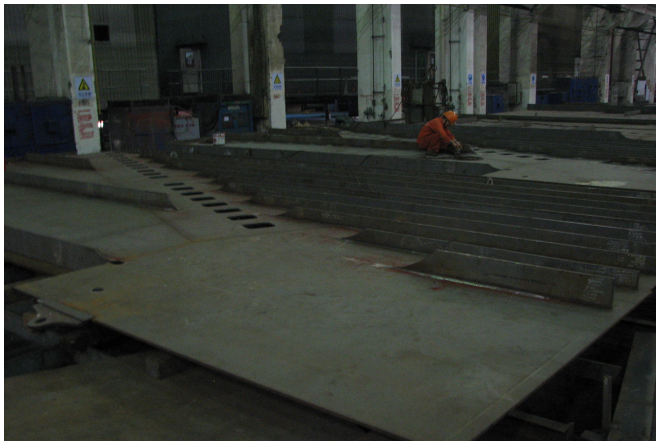
Bay 7: Caltrans QA inspector performed magnetic particle testing (MT) per ZPMC notification of witness inspection document dated September 04, 2008, document number 00976. The subassembly is identified as OBG floor beam FB029-001. Caltrans QA inspector observed that the welds for the subassembly were MT and accepted by ZPMC Quality Control (QC) inspector, Mr. Xu Hai, dated 09-04-08 on the subassembly. See Caltrans Magnetic Particle Test Report (TL-6028) dated September 04, 2008 for additional information. The following digital pictures illustrate subassembly FB029-001 MT inspection.
